**Murray Construction Services, Inc.**  
70 Yosemite Ave. South Exposure Investigative Stucco Removal

**Southwest Corner**  
**Example of damage as a result of Roof/Rake Eave edge assembly**

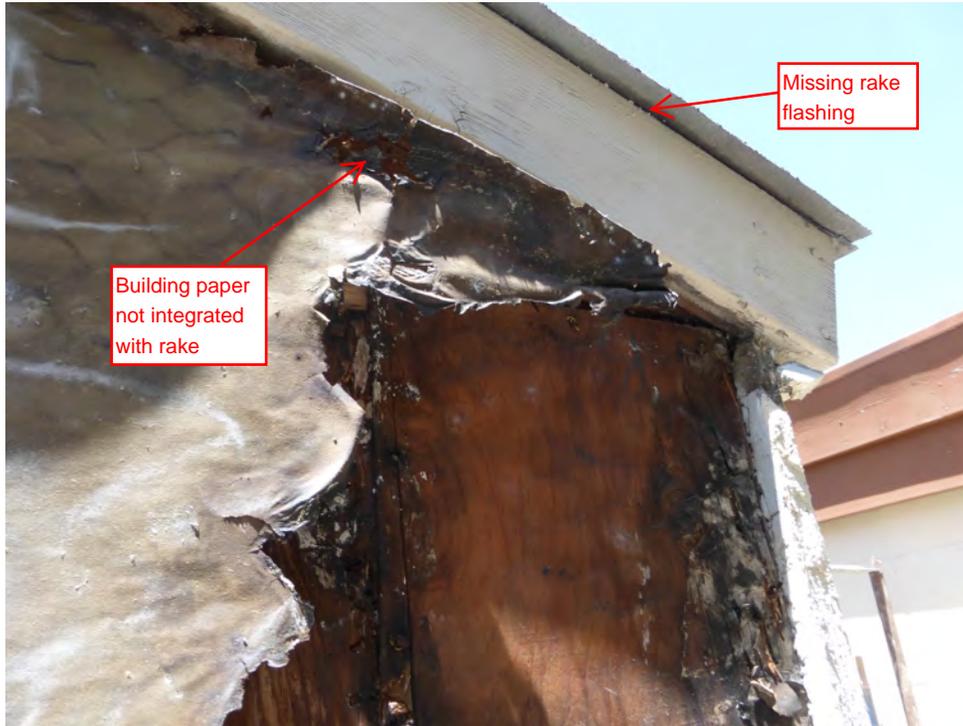
During the investigative removal process, evidence of water intrusion was noted as a result of missing roof rake nosing and non-integrated building paper.

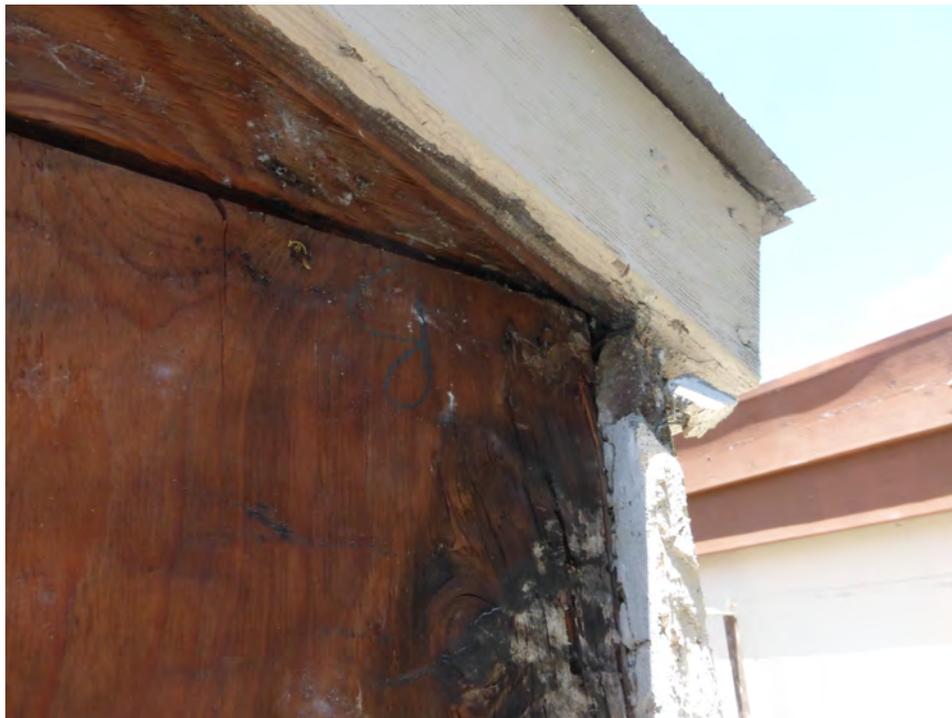
Lack of roof/wall integrated waterproofing allowing moisture infiltration behind building paper.

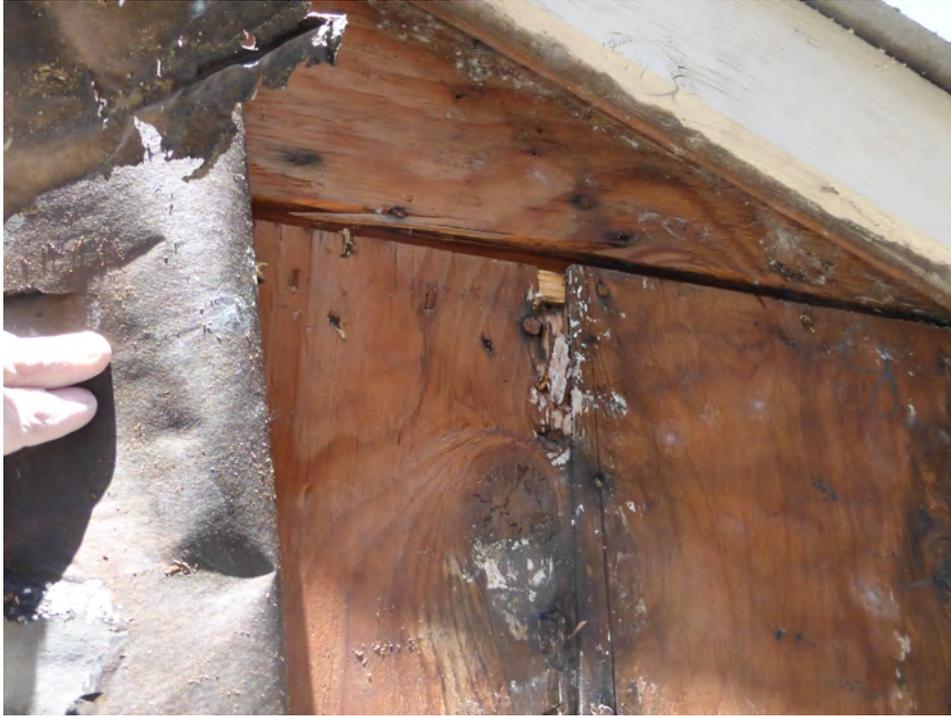
More of the same.

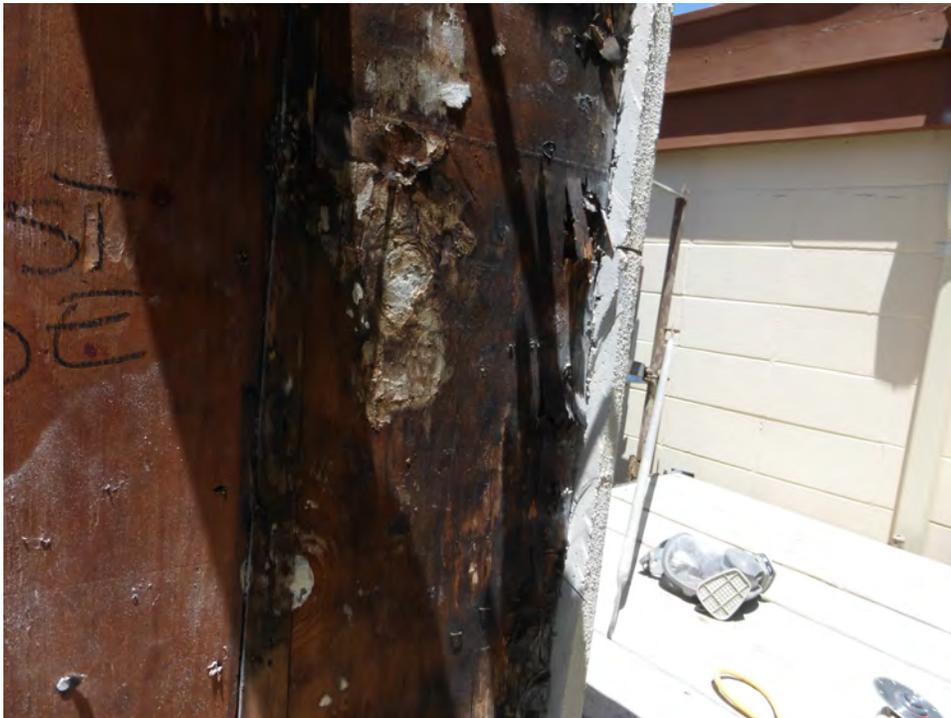
Continuation of accumulated moisture damage as a result of the above.

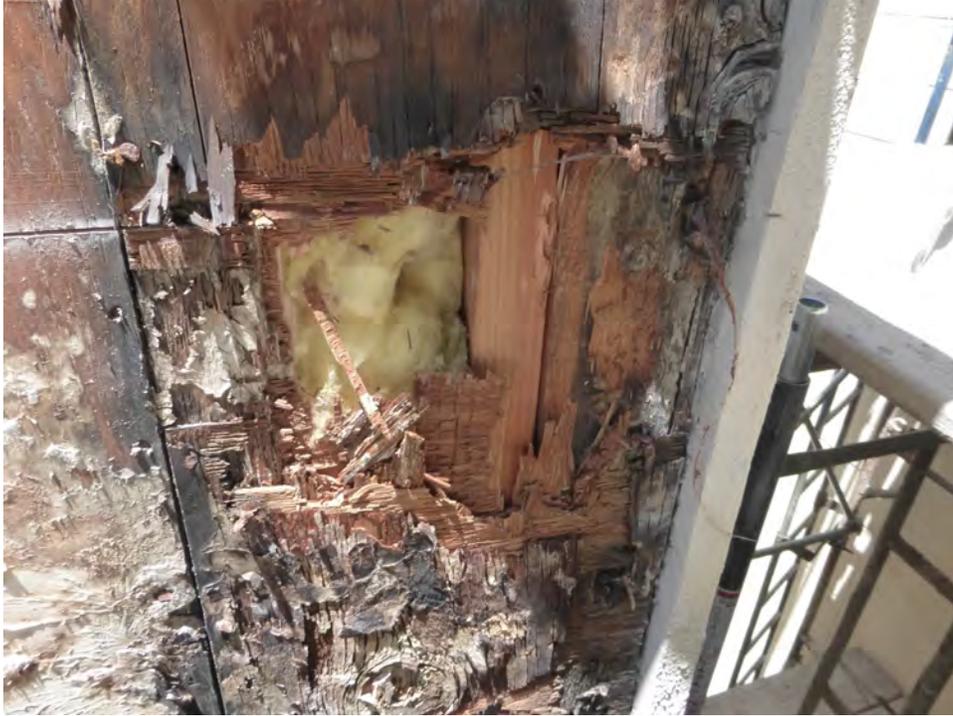
More of the same extending down the building corner causing dry rot and severely compromising the structural shear.

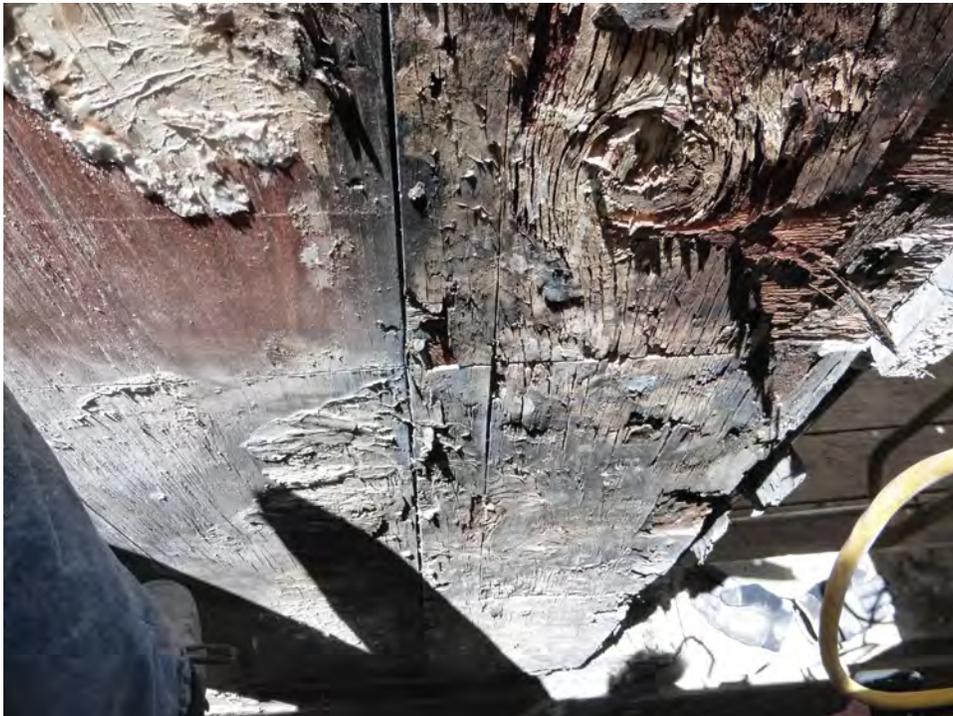
More of the same extending and expanding down the building corner.

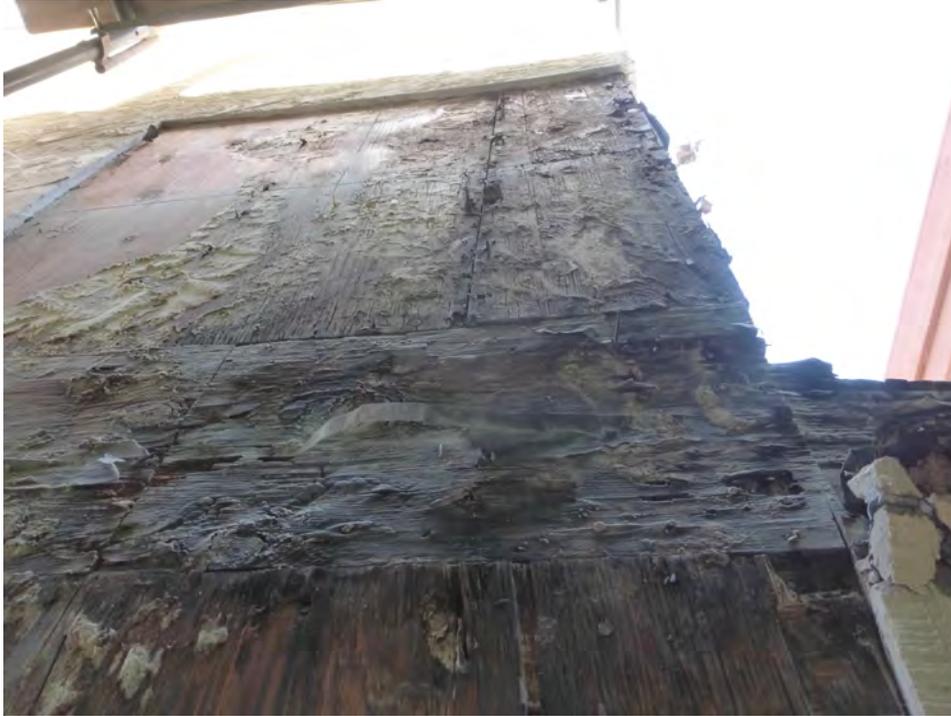
Severe dry rot noted at the upper lateral support beam as a result of missing roof related and beam/wall juncture flashings.

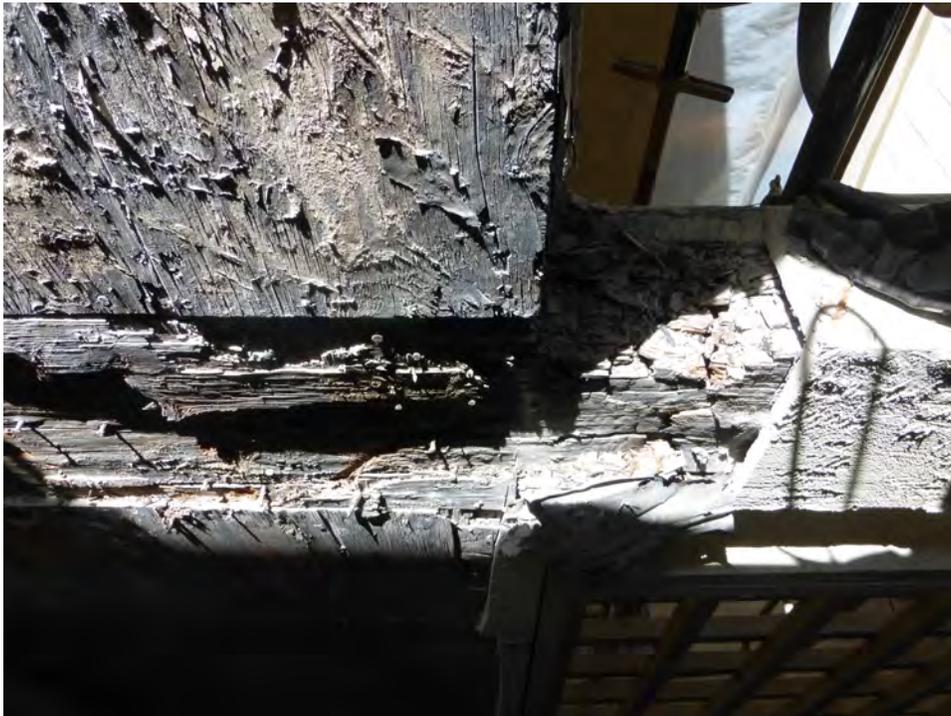
More of the same.

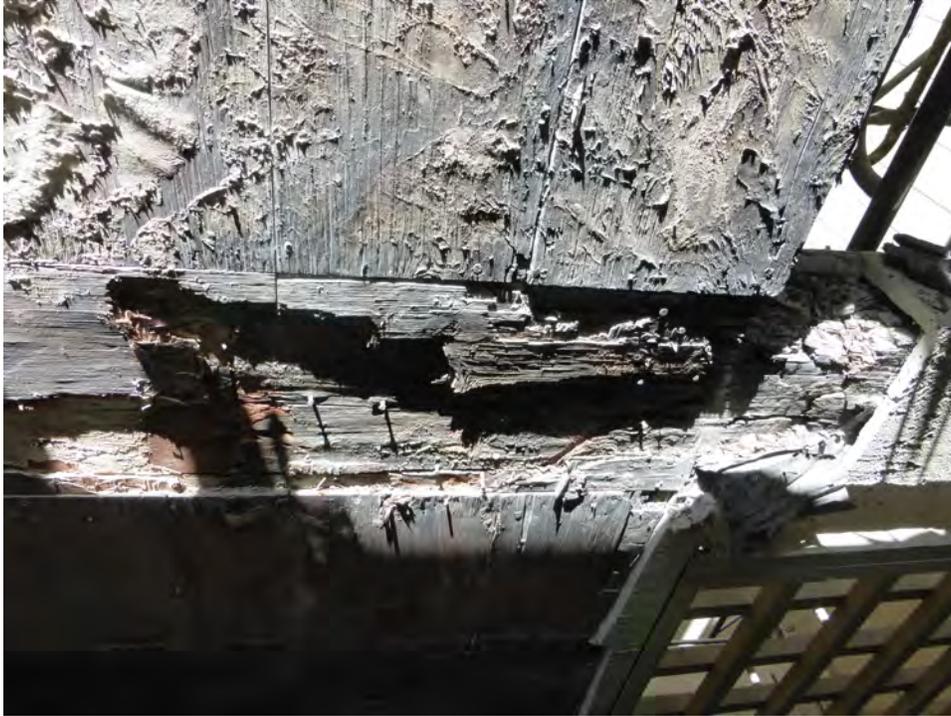
More of the same expanding along lateral beam and rim.

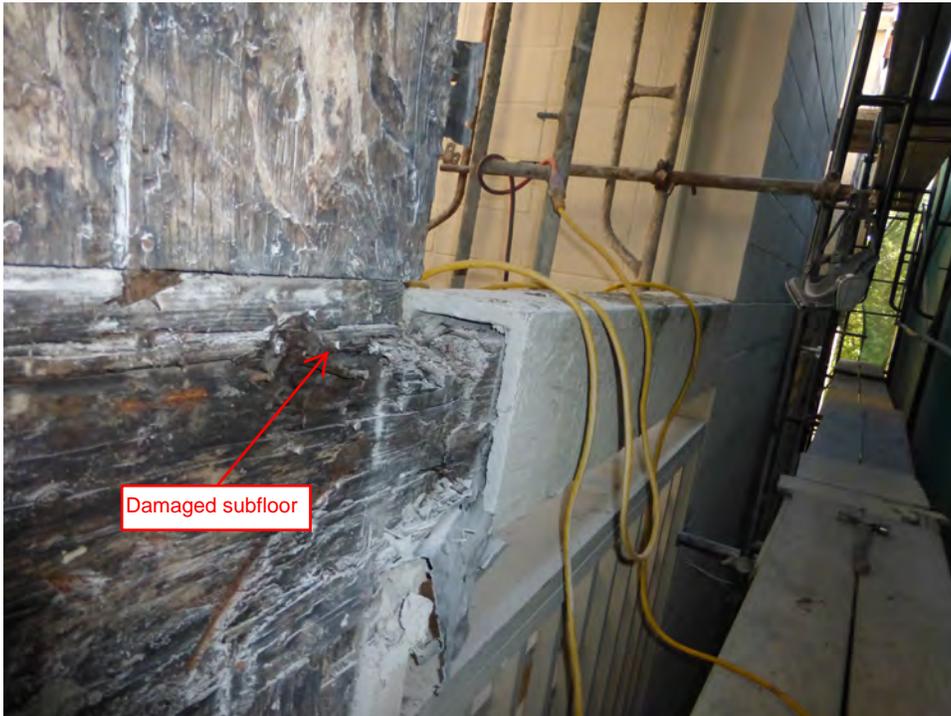
More of the same. Noted dry rot damage at subfloor possibly extending into the unit.

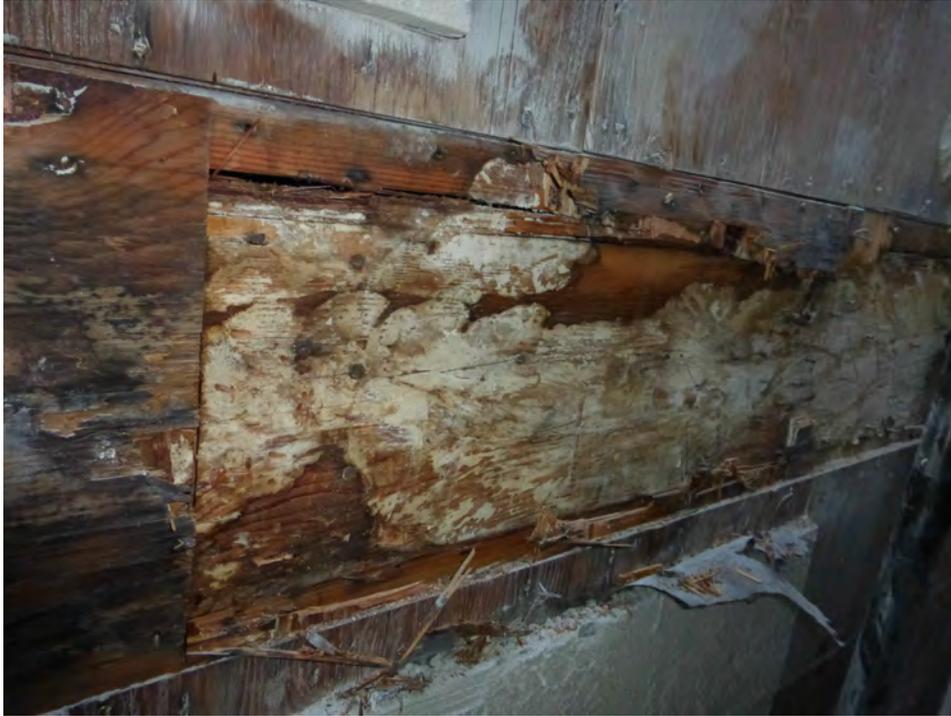
Moisture damage and fungal growth traveling along rim board behind plywood sheer.

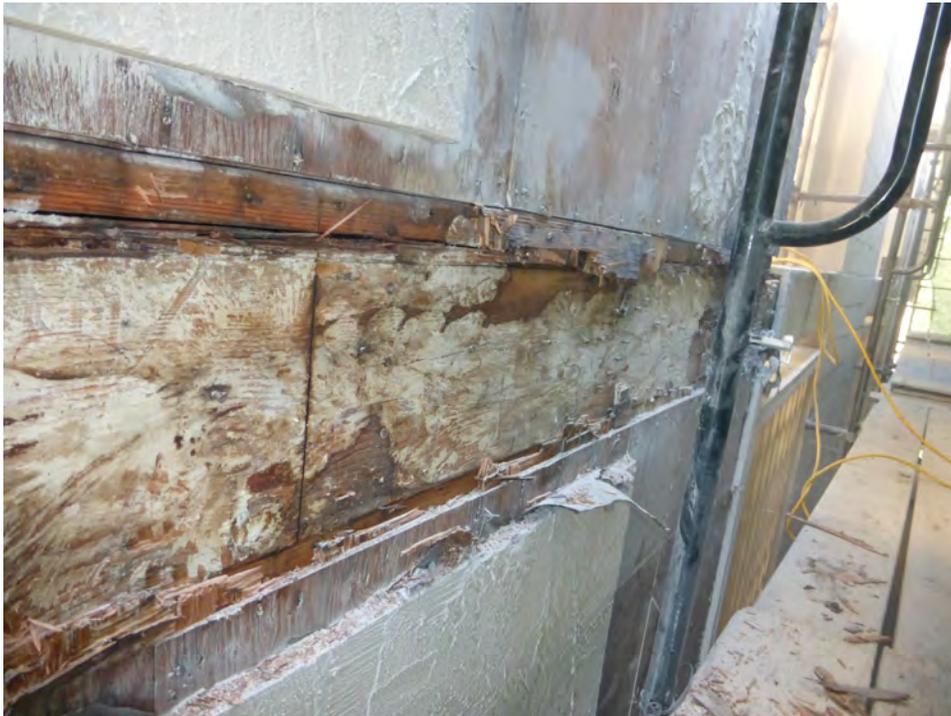
More of the same.

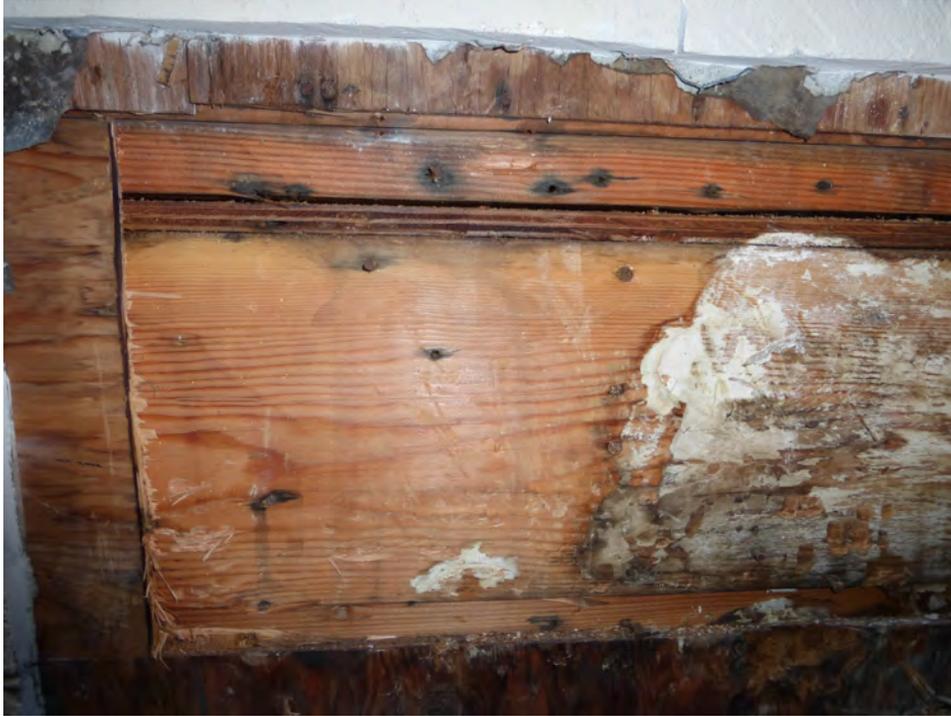
More of the same.

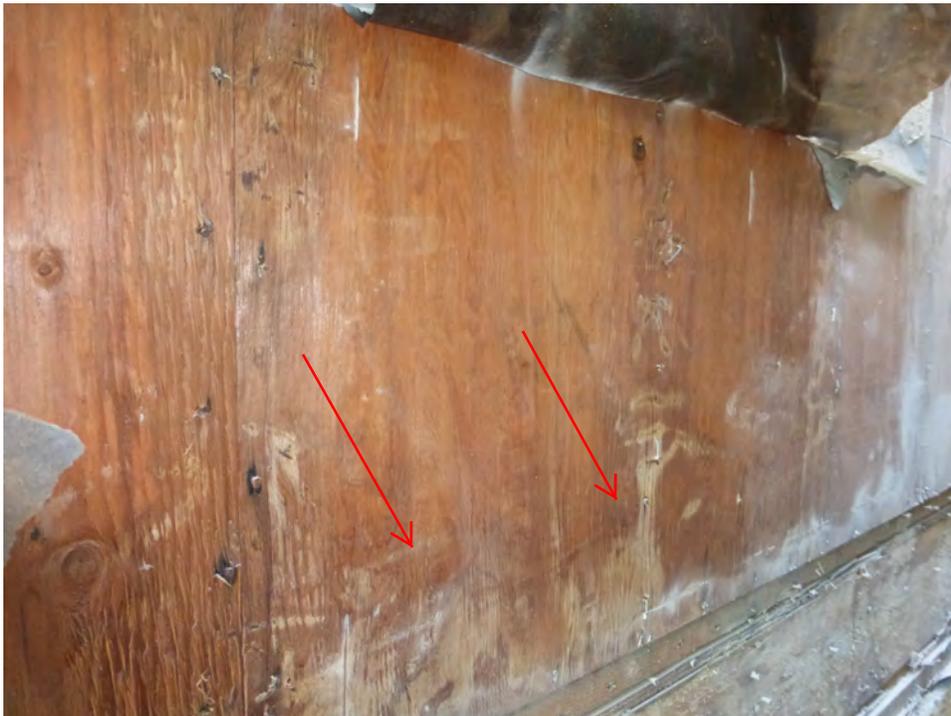
More evidence of moisture penetration beyond building paper.

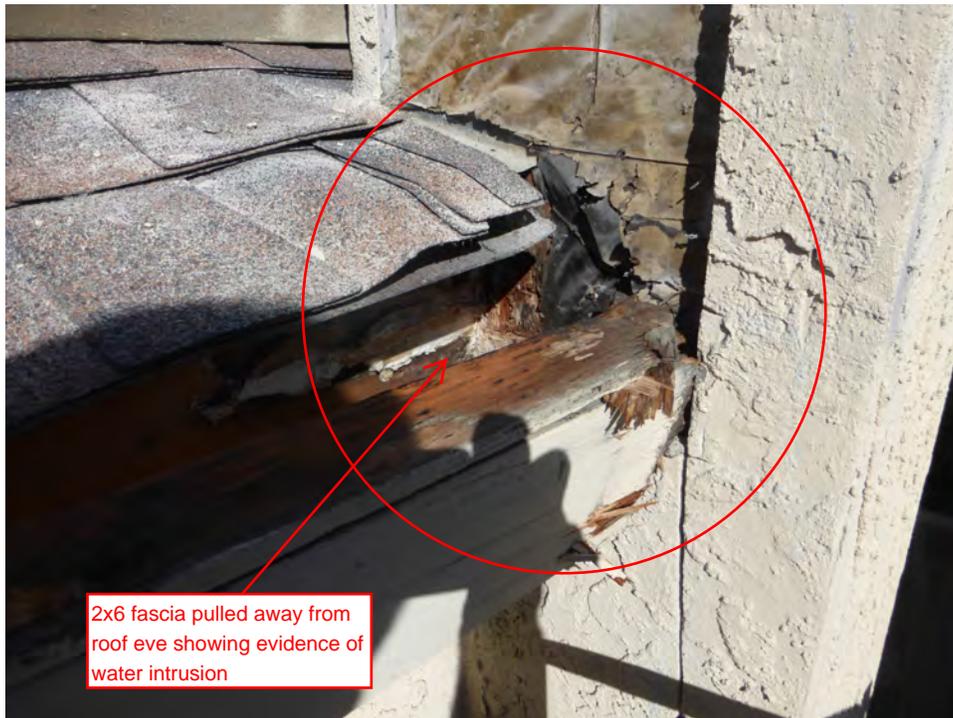
**Southwest Corner Chimney Chase**  
Example of damage as a result of Roof/Rake Eave edge assembly

Missing roof edge flashing, gutter and diverter allowing water intrusion at confined rake of chimney chase.

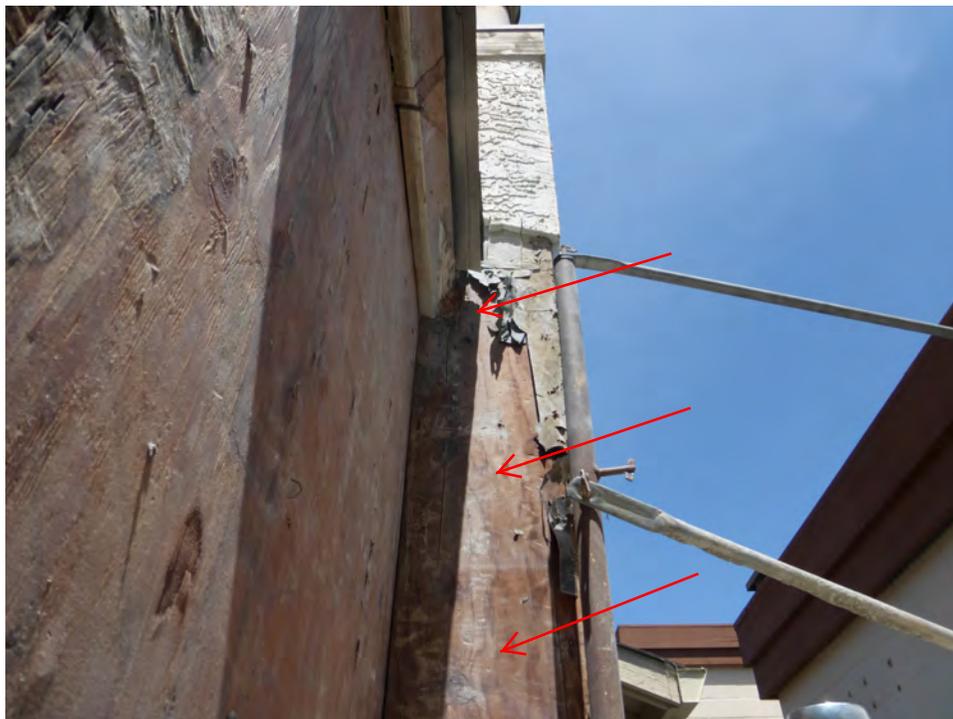
Evidence of water intrusion at chimney chase directly below roof/chimney chase wall juncture.

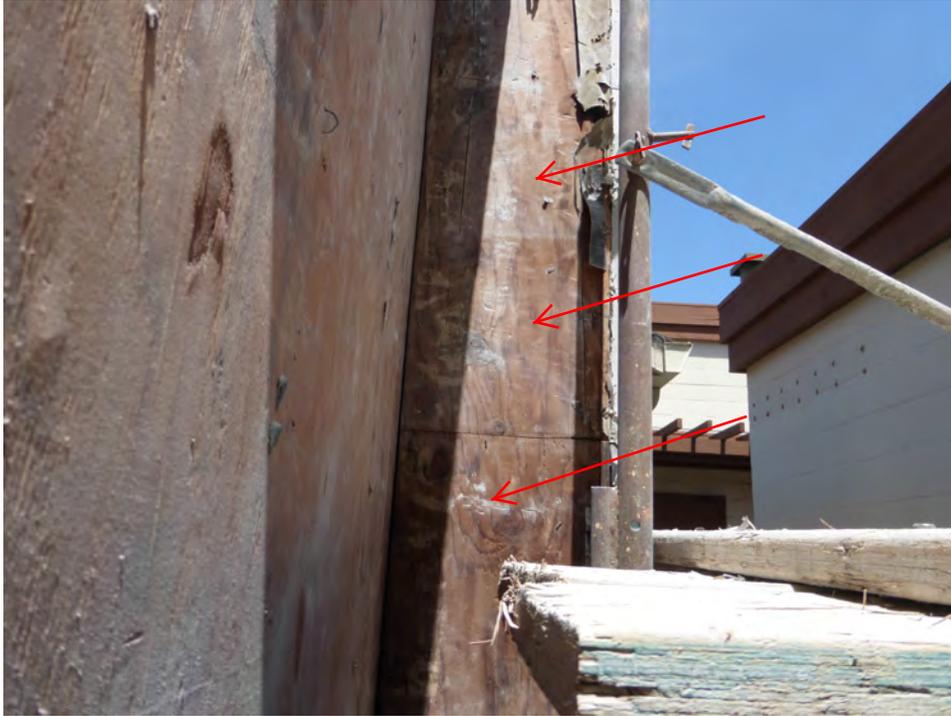
More of the same.

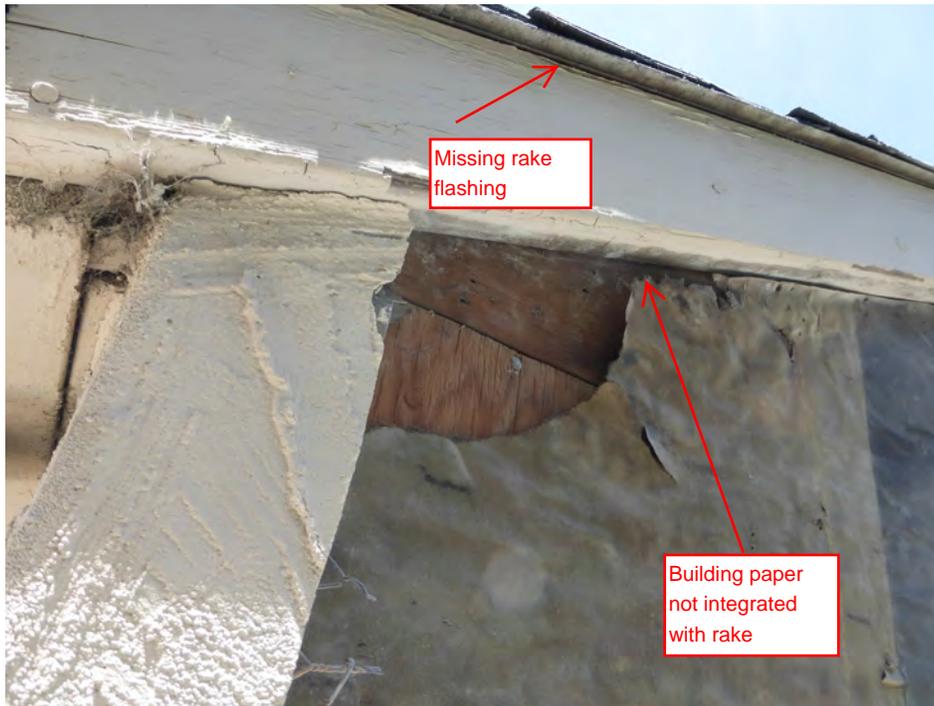
**Southeast Exposure Example of damage as a result of Roof/Rake Eave edge assembly and stucco control joint**

Evidence of water intrusion was noted as a result of missing roof rake nosing and non-integrated building paper similar to conditions found at the east corner.

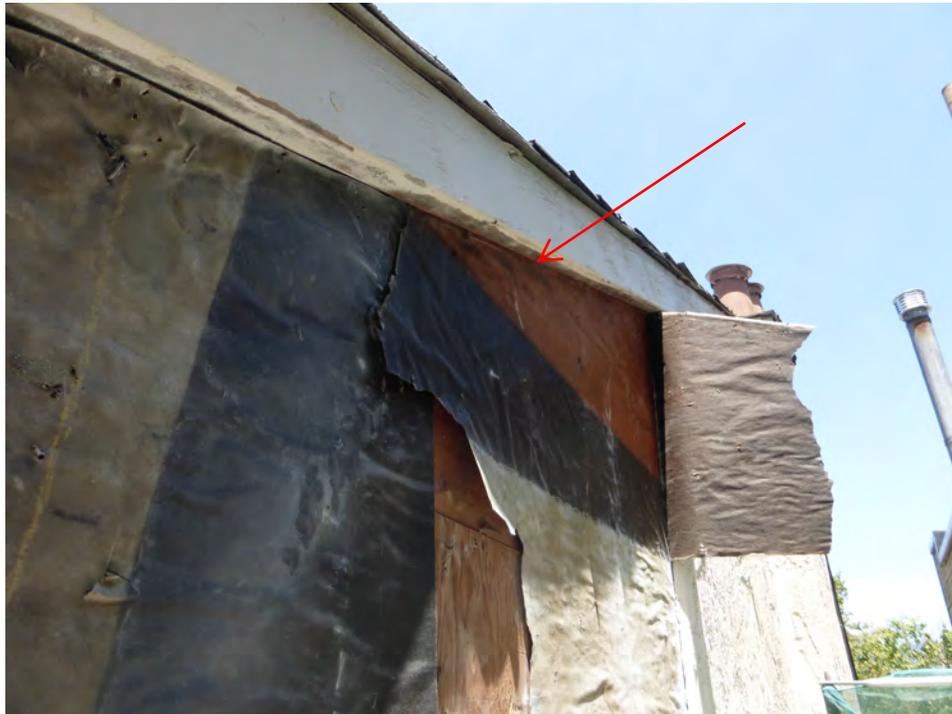
Evidence of moisture behind building paper

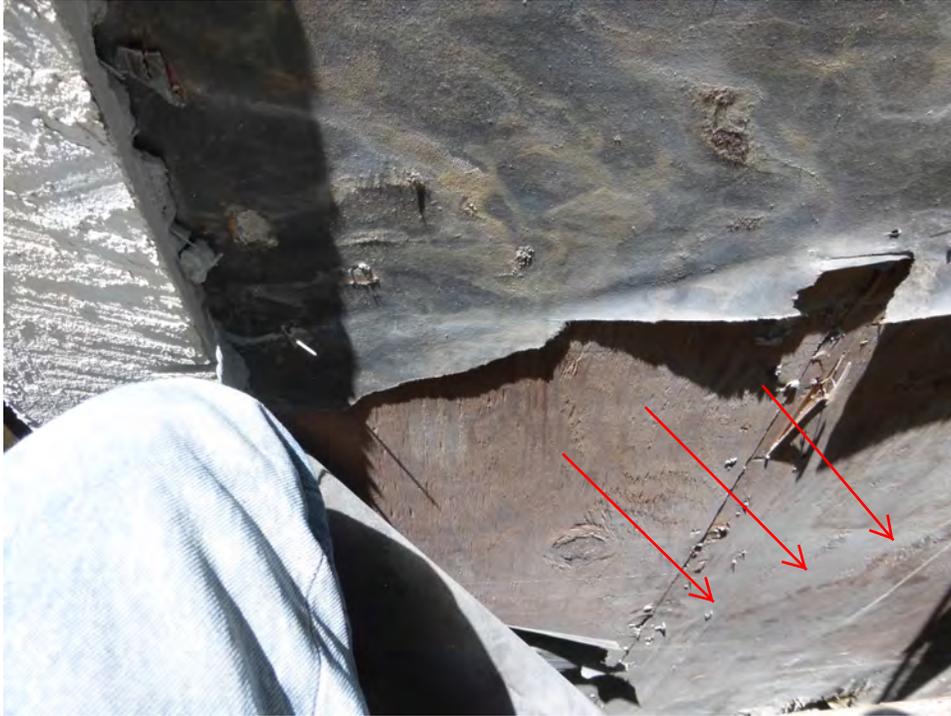
Minor evidence of water staining at sheer plywood midway between roof and upper lateral beam.

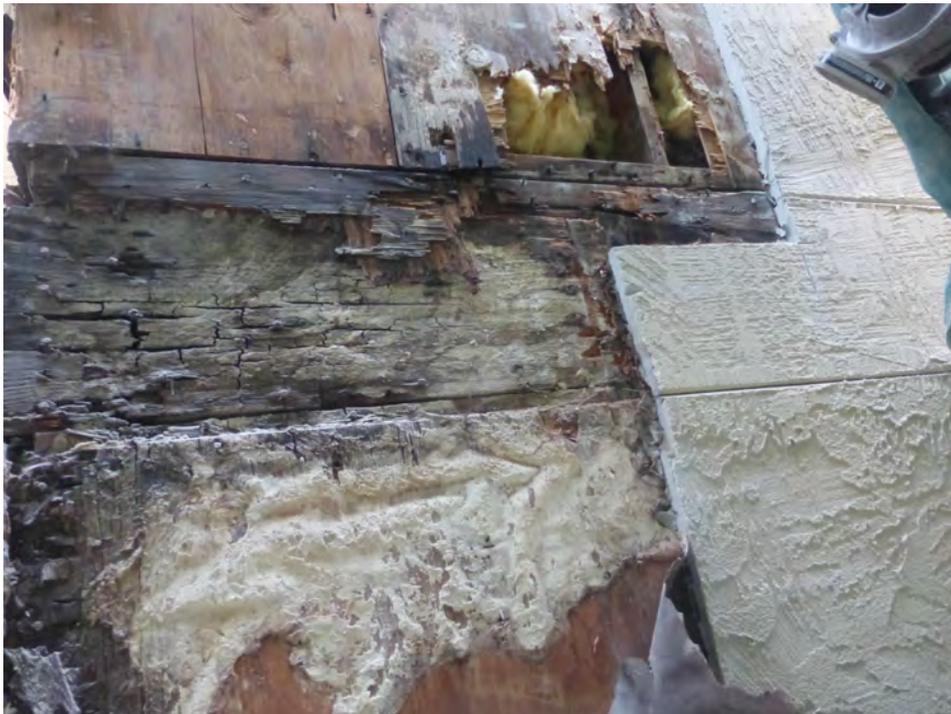
Severe structural damage appears to be related to improper stucco control joint installation. Similar condition present at south east corner of the building.

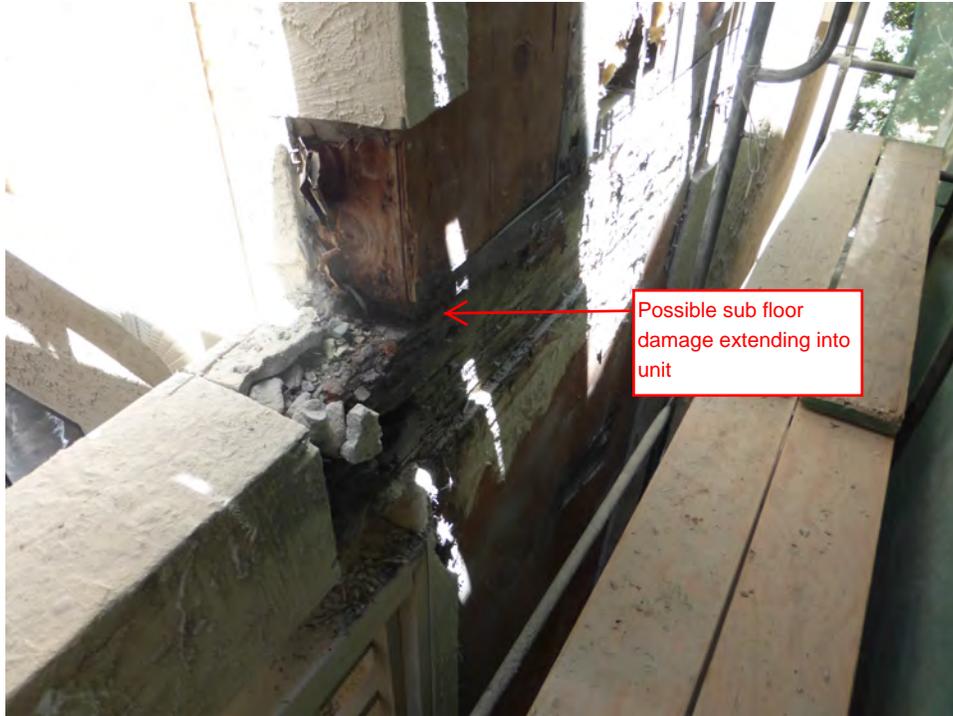
More of the same extending to exposed lateral beam. Noted dry rot to sub-floor and possibly continuing into the unit.

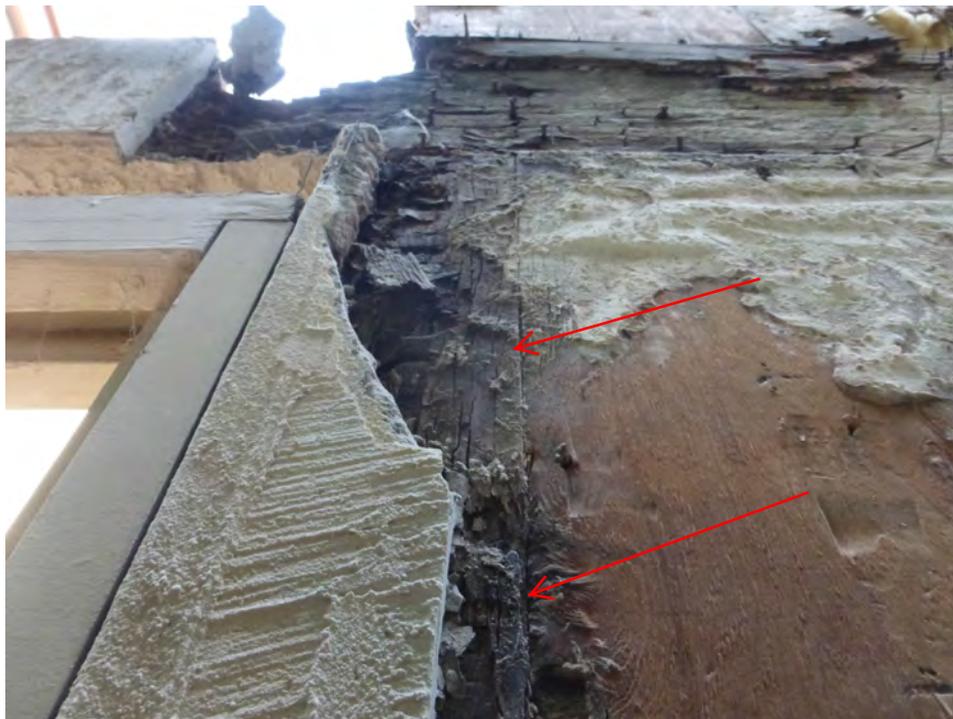
More of the same with damage continuing down the building corner.

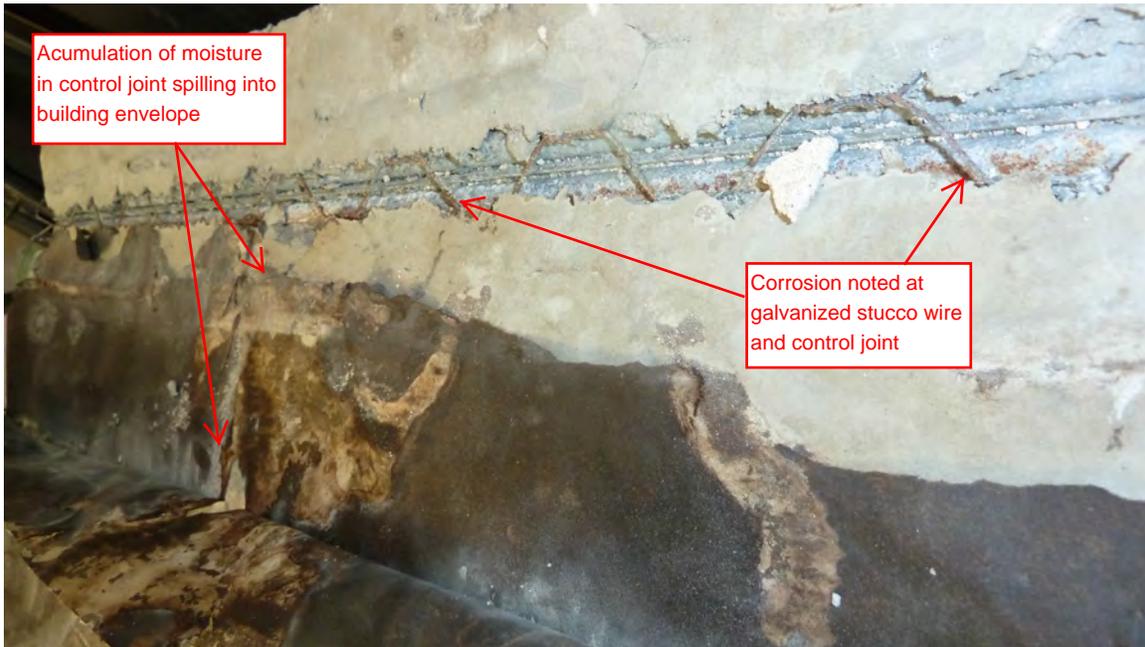
Example of stucco control joint installed directly over stucco wire creating a path for moisture, breaking down building paper and allowing infiltration into the building envelope.
