#	Oakland Facility Assessment Checklist Instructions
1	City of Oakland tab: Existing Documentation section items are requested to be provided to Consultant before site assessment.
2	City of Oakland tab: Facilities and User Questions section is to be completed by Public Works and building user groups.
3	Summary tab is meant to be a quick review of major building systems. See Systems tab for more detail.
4	Accessibility tab: initial accessibility review items provided as indicators for items requiring further investigation. Accessibility review is not CASP level review or inspection.
5	Systems tab: provide unique 3-digit number in first column labeled ### for identification. Numbers to be added at end of assessment process.
6	Systems tab: delete unused rows in spreadsheet and add new rows as needed for building components.
7	Systems tab: maintain 1 letter + 4-digit numbering system when removing and adding new rows. If items in group exceed ten items group can expand to the next tenth grouping. Adjust overall numbering scheme as needed.

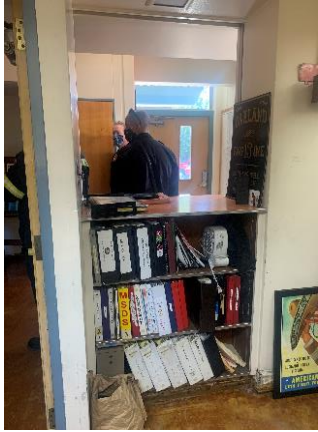
SPACE	ITEM	OPERATIONAL REVIEW	MODIFICATION	PRIORITY	PHOTO
Public Space	Lobby secure to Watch Office Space for Well Checks	Lobby is open to watch office Photo: Watch Office to Lobby	Add Pass through window at opening.	Low

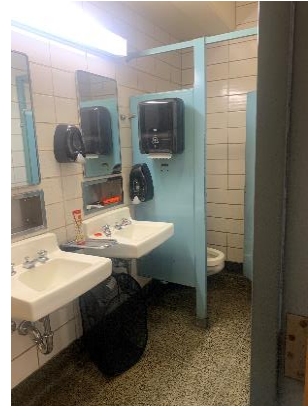
Space for Well Checks	There is space for a chair for well checks.	None		
Accessible Public Restroom	Accessible Public Restroom	No dedicated public restroom, no restrooms are accessible Photo: Captain's Restroom adjacent to Lobby	Create accessible restroom to share with Station Captain	Required if renovated

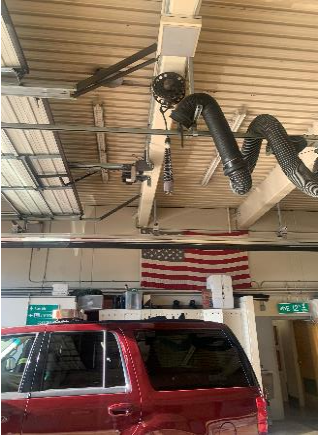
SPACE	ITEM	OPERATIONAL REVIEW	MODIFICATION	PRIORITY	PHOTO
Apparatus Bays	Apparatus Bay Door Operation/condition	Good Condition, newly replaced.	N/A	N/A	
	Floor Drains in Bay	Yes	N/A	N/A	
	Vehicle Tailpipe Extraction System	Non-Operational, Currently the Department uses WARDS No Smoke for exhaust control. Photo: Tail-pipe System to be removed	Remove obsolete system	Low

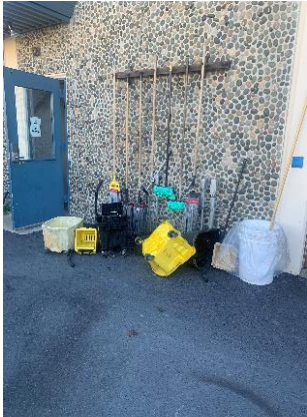
SPACE	ITEM	OPERATIONAL REVIEW	MODIFICATION	PRIORITY	PHOTO
	Dedicated janitors room	Janitor room not large enough for supply and equipment storage. Only one in bathroom area. Photo: Janitor equipment outside	Expand or add a second for apparatus bays	Medium - Recommended if station is renovated

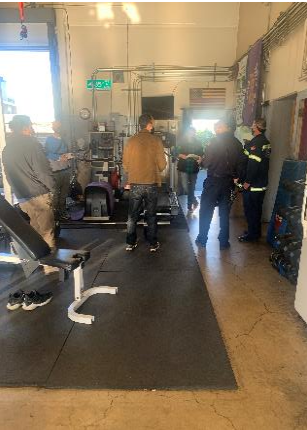
Dedicated Fitness Room	Fitness equipment is in the apparatus bay Photo: Fitness Equipment in Apparatus Bay	Expand station for dedicated fitness room	Highest

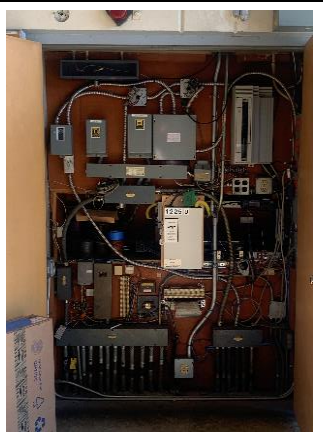
Dedicated Comm. Room with air-conditioning	Comm equipment is in a closet off the apparatus bay and is not conditioned. Photo: Data closet off apparatus bay	Create dedicated Comm Room.	Medium - Recommended if station is renovated

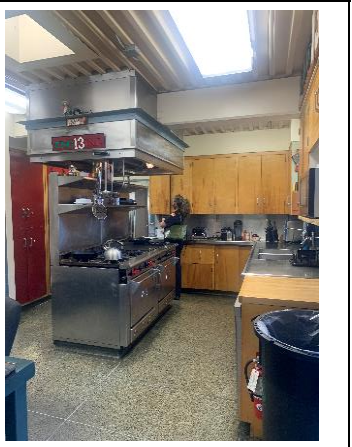
SPACE	ITEM	OPERATIONAL REVIEW	MODIFICATION	PRIORITY	PHOTO
Kitchen	Casework Condition	Recently refinished by the Firefighters Photo: Kitchen	N/A

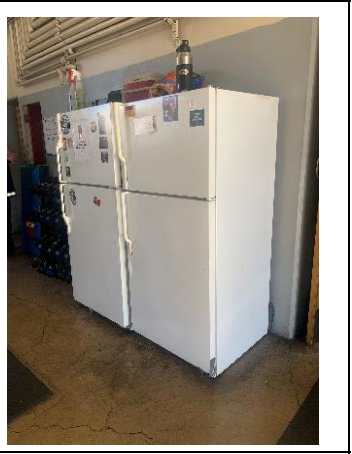
Stainless Steel Counters	Good Condition			
	Adequate shift storage and house storage	Adequate Storage for dry goods			
	Three refrigerators	All refrigerators are in the apparatus bay Photo: Refrigerators in apparatus bay	Expand kitchen area to accommodate all food storage systems.	High

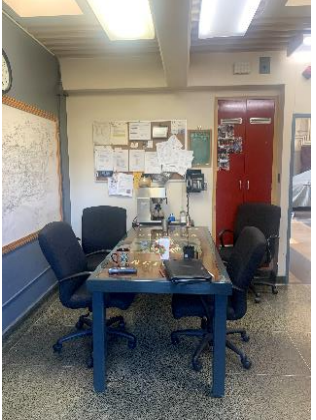
SPACE	ITEM	OPERATIONAL REVIEW	MODIFICATION	PRIORITY	PHOTO
Dining Room	Sized to accommodate shift change meeting	Adequate size for shift change meeting with staff standing. Photo: Dining Area	N/A

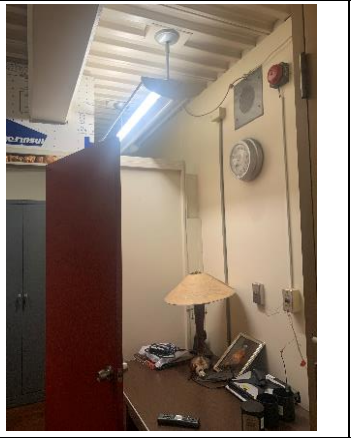
SPACE	ITEM	OPERATIONAL REVIEW	MODIFICATION	PRIORITY	PHOTO
Sleeping	Privatized Living Quarters	<p>Private sleeping rooms have been provided although they are partially open to the hallway and do not isolate sound. They do not meet current fire code separations. Photo: Typical Sleeping Room open to hallway</p>	<p>The size of the rooms are generous.</p>	<p>Medium - Reconfigure and upgrade sleeping rooms.</p>

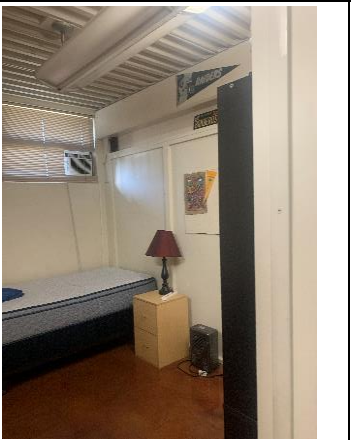
Emergency egress from sleeping room windows	<p>Windows do not meet code for egress. Photo: Sleeping Room with egress windows</p>	<p>Lowering windows will be required as a part of a renovation</p>	<p>Medium - Address with Station Renovation</p>

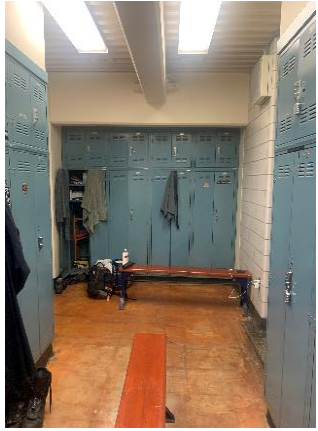
SPACE	ITEM	OPERATIONAL REVIEW	MODIFICATION	PRIORITY	PHOTO
Dressing	Locker placement to accommodate dynamic staffing models	Some lockers are located in areas to accommodate dynamic staffing Photo: Locker dressing Area	Eliminate this space and create a gender neutral personnel locker area that responds to dynamic staffing goals.	Medium - Address with Station Renovation

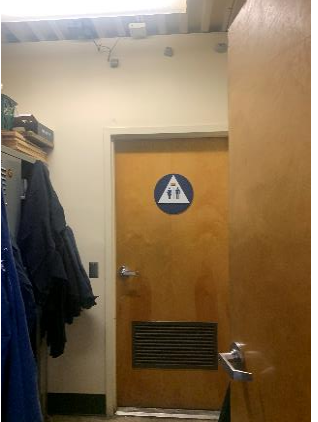
Gender neutral Restrooms with showers	Accommodations have been made for a private restroom/dressing area. Photo: Door to private dressing area	Renovate existing restroom and locker area to provide gender quality and privacy	Medium - Address with Station Renovation

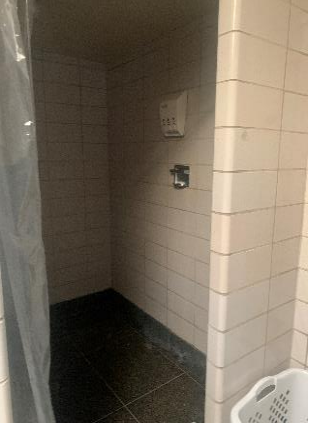
SPACE	ITEM	OPERATIONAL REVIEW	MODIFICATION	PRIORITY	PHOTO
Restrooms/Showers	Adequate number of restrooms for staffing (.75 per staff Member)	The number of restrooms is adequate.	Shower number is not adequate.	Medium - Address with Station Renovation

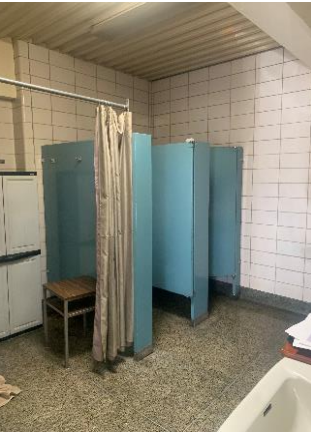
Accessible Staff Shower and restroom	None of the restrooms are accessible Photo: Firefighter restroom	Accessibility will be met through a renovation.	Medium - Address with Station Renovation
