#	Oakland Facility Assessment Checklist Instructions
1	City of Oakland tab: Existing Documentation section items are requested to be provided to Consultant before site assessment.
2	City of Oakland tab: Facilities and User Questions section is to be completed by Public Works and building user groups.
3	Summary tab is meant to be a quick review of major building systems. See Systems tab for more detail.
4	Accessibility tab: initial accessibility review items provided as indicators for items requiring further investigation. Accessibility review is not CASP level review or inspection.
5	Systems tab: provide unique 3-digit number in first column labeled ### for identification. Numbers to be added at end of assessment process.
6	Systems tab: delete unused rows in spreadsheet and add new rows as needed for building components.
7	Systems tab: maintain 1 letter + 4-digit numbering system when removing and adding new rows. If items in group exceed ten items group can expand to the next tenth grouping. Adjust overall numbering scheme as needed.

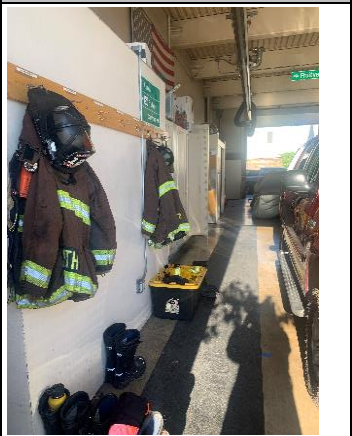
SPACE	ITEM	OPERATIONAL REVIEW	MODIFICATION	PRIORITY	PHOTO
Apparatus Support	Dedicated Turn out Storage Room with two lockers for assigned fire fighter	Turnouts stored in bay	Add dryer and modify existing laundry to hold turnout lockers. Provide continuous exhaust.	High - Recommend adding this space.

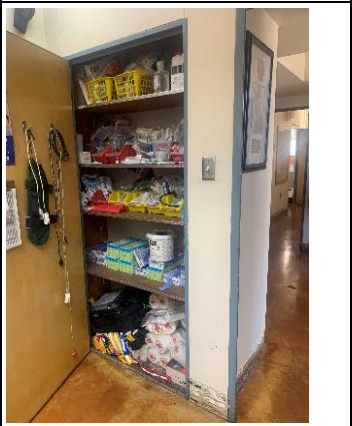
Extractor and Dryer for apparatus and hose	Station has an extractor	Add dryer	modifying this space so that it is	
	Medical Supply Storage	Medical Supply storage in Watch Office	Area adequate
