Project No.
6964.1.001.01

Subject: Oakland Area Geologic Hazard Abatement District (GHAD)
Oakland, California

**GEOLOGIC HAZARD ABATEMENT DISTRICT (GHAD)
PLAN OF CONTROL**

**OAKLAND AREA GHAD
OAKLAND, CALIFORNIA**

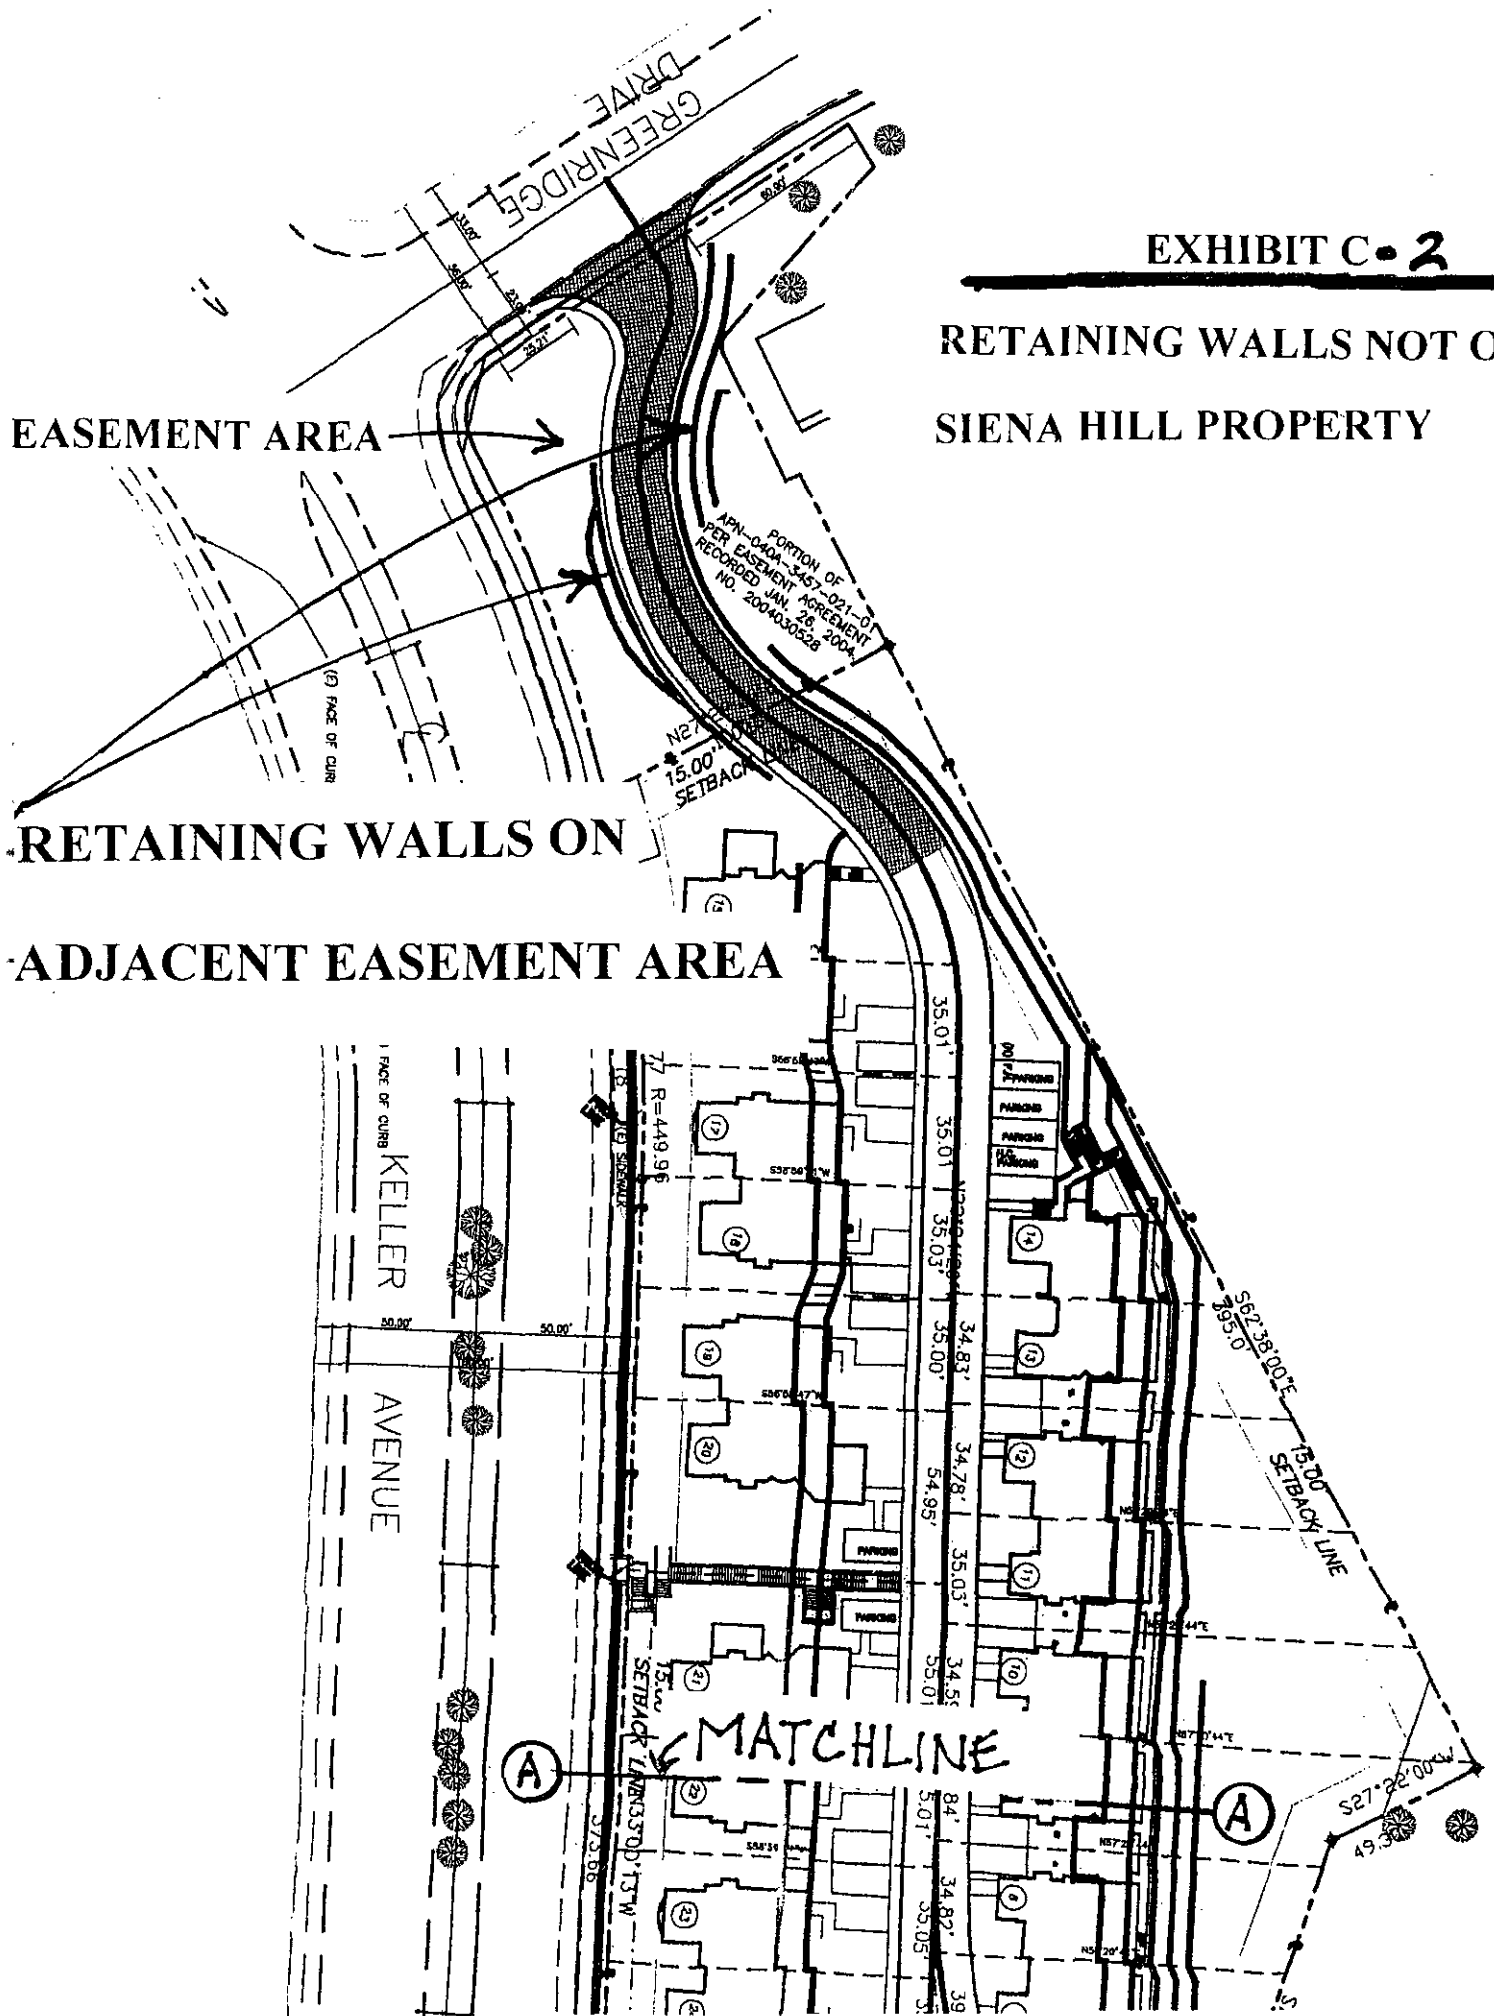
EASEMENT AREA

**RETAINING WALLS ON
ADJACENT EASEMENT AREA**
