## INTRODUCTION

The purpose of this document is to provide a framework for the management and maintenance of the Parcel "C" Water Quality/Detention Pond at the Leona Quarry. Parcel "C" is located adjacent to the Mountain Boulevard on-ramp to Interstate 580 on the southwestern edge of the Leona Quarry development. As planned, the Leona Quarry site will be developed for attached and detached single-family homes, approximately 2 acres of park space and 3 recreation areas. The detention basin will be used to mitigate peak flows from the surface runoff on the subject site in addition to some storm water flows from the off-site Ridgemont Development as requested by the Alameda County Flood Control District. The detention basin design was based on results from hydrology modeling by Balance Hydrologics.

Leona Quarry Slope Revegetation Plan

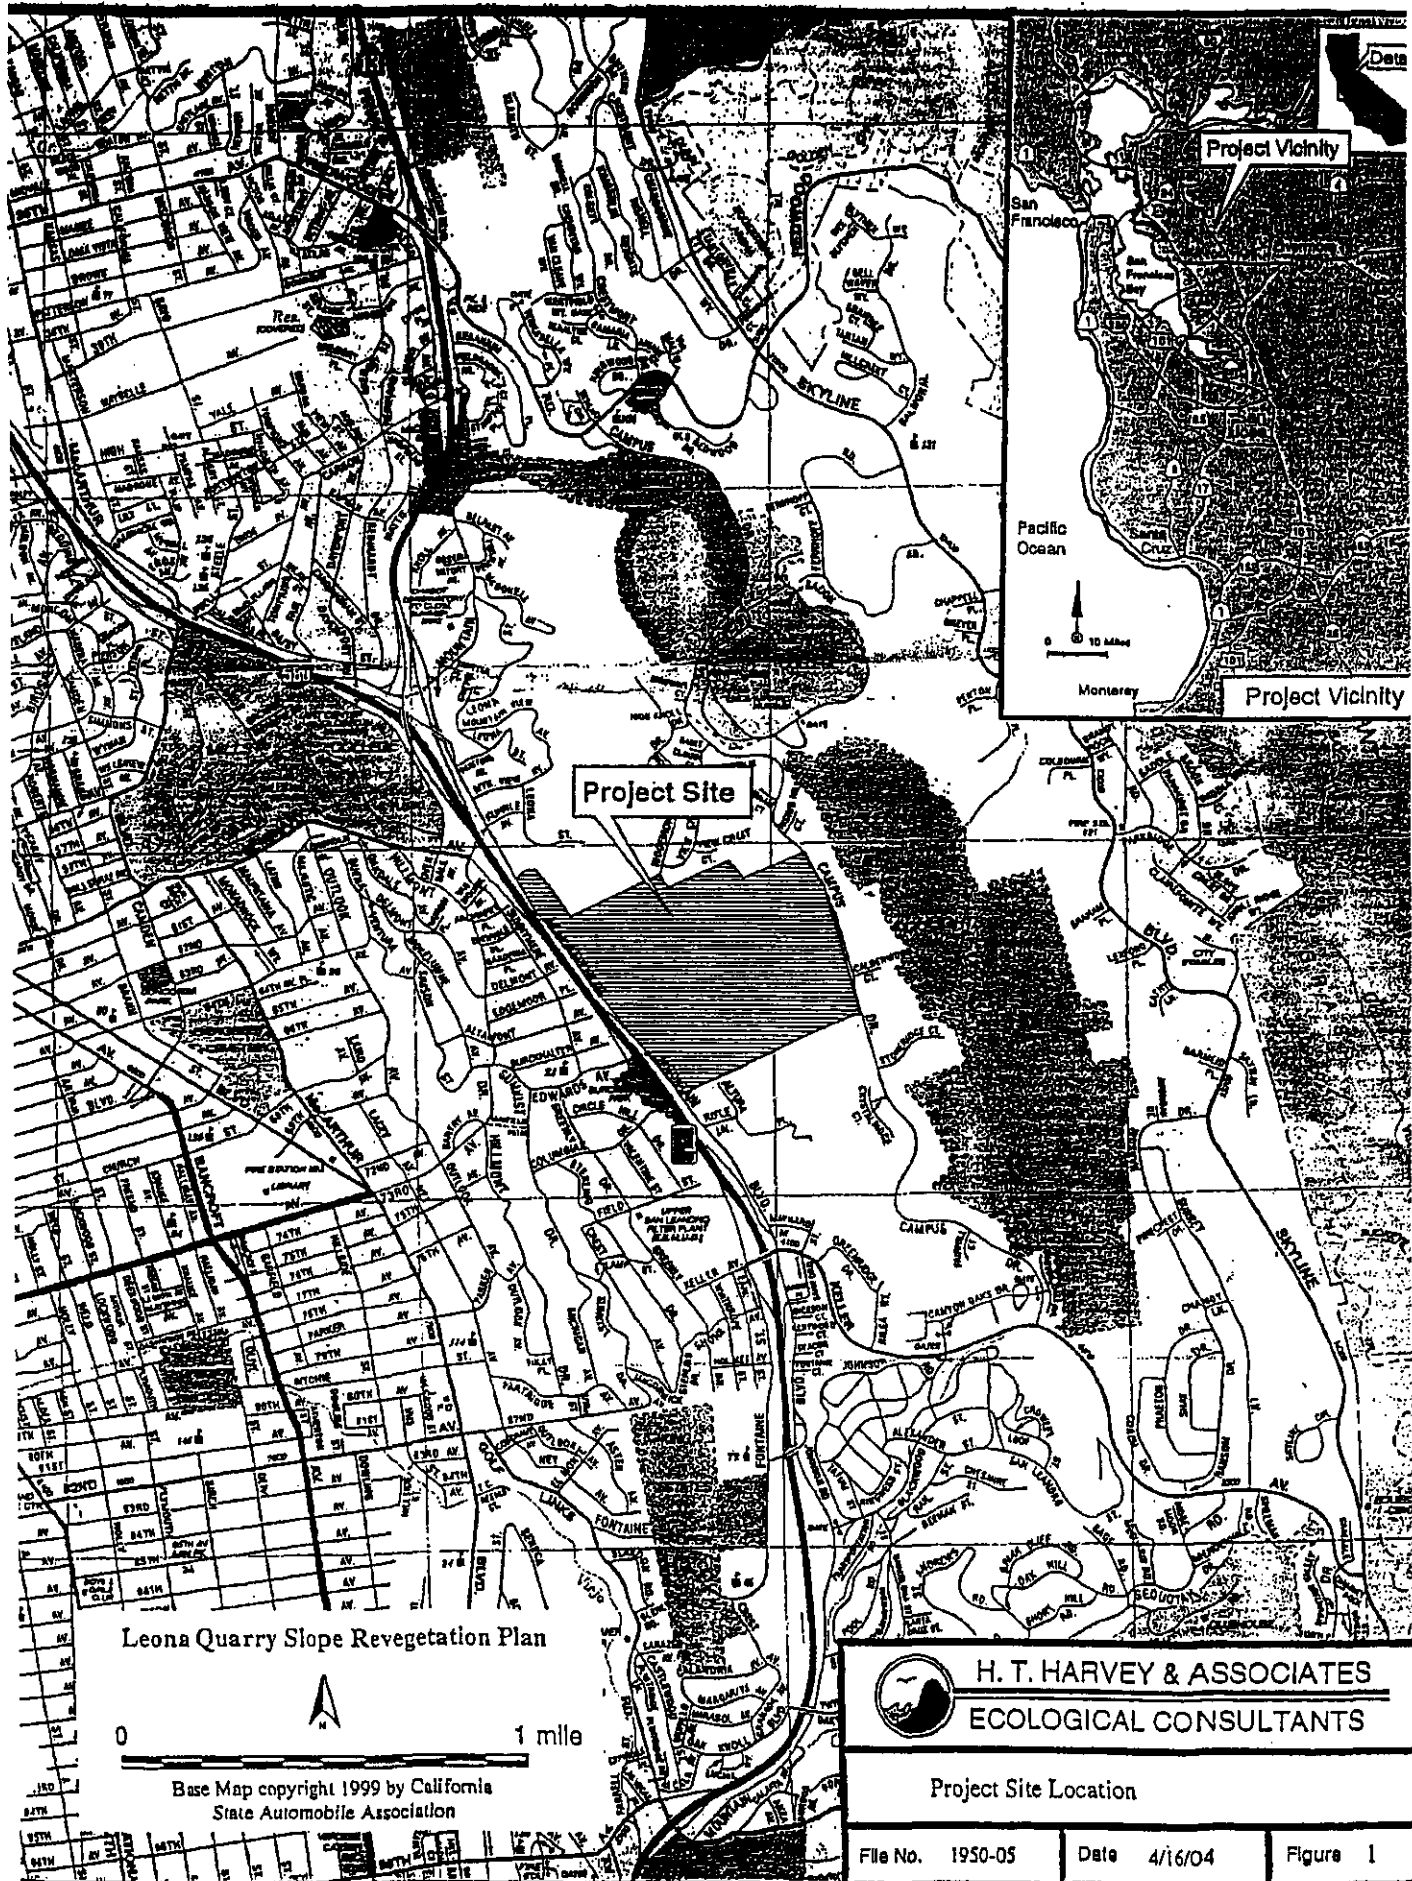
File No. 1950-05	Date 4/16/04	Figure 1
------------------	--------------	----------

Project Site Location

The Leona Quarry project site is located in southeast Oakland, Alameda County, California (Figure 1). Residential development, Highway 580 and Mountain Boulevard border the site to the south and southwest. The site extends upslope and is bordered to the northeast by Campus Drive and residential development. The Leona Heights Regional Open Space Preserve is located approximately 1.5 miles to the northeast. Relatively undisturbed sage scrub, chaparral and oak woodland vegetation border the site to the east and west. Located in the East Bay Hills, elevations at the site range from 300 feet on the southwestern portion of the quarry floor to 1067 feet along the quarry crest adjacent to Campus Drive. The Leona Quarry has been in operation as a rock quarry since the early 1900s. Throughout the life of the quarry, quarrying activities have severely altered the topography, soils and vegetation throughout the majority of the approximately 128-acre site.

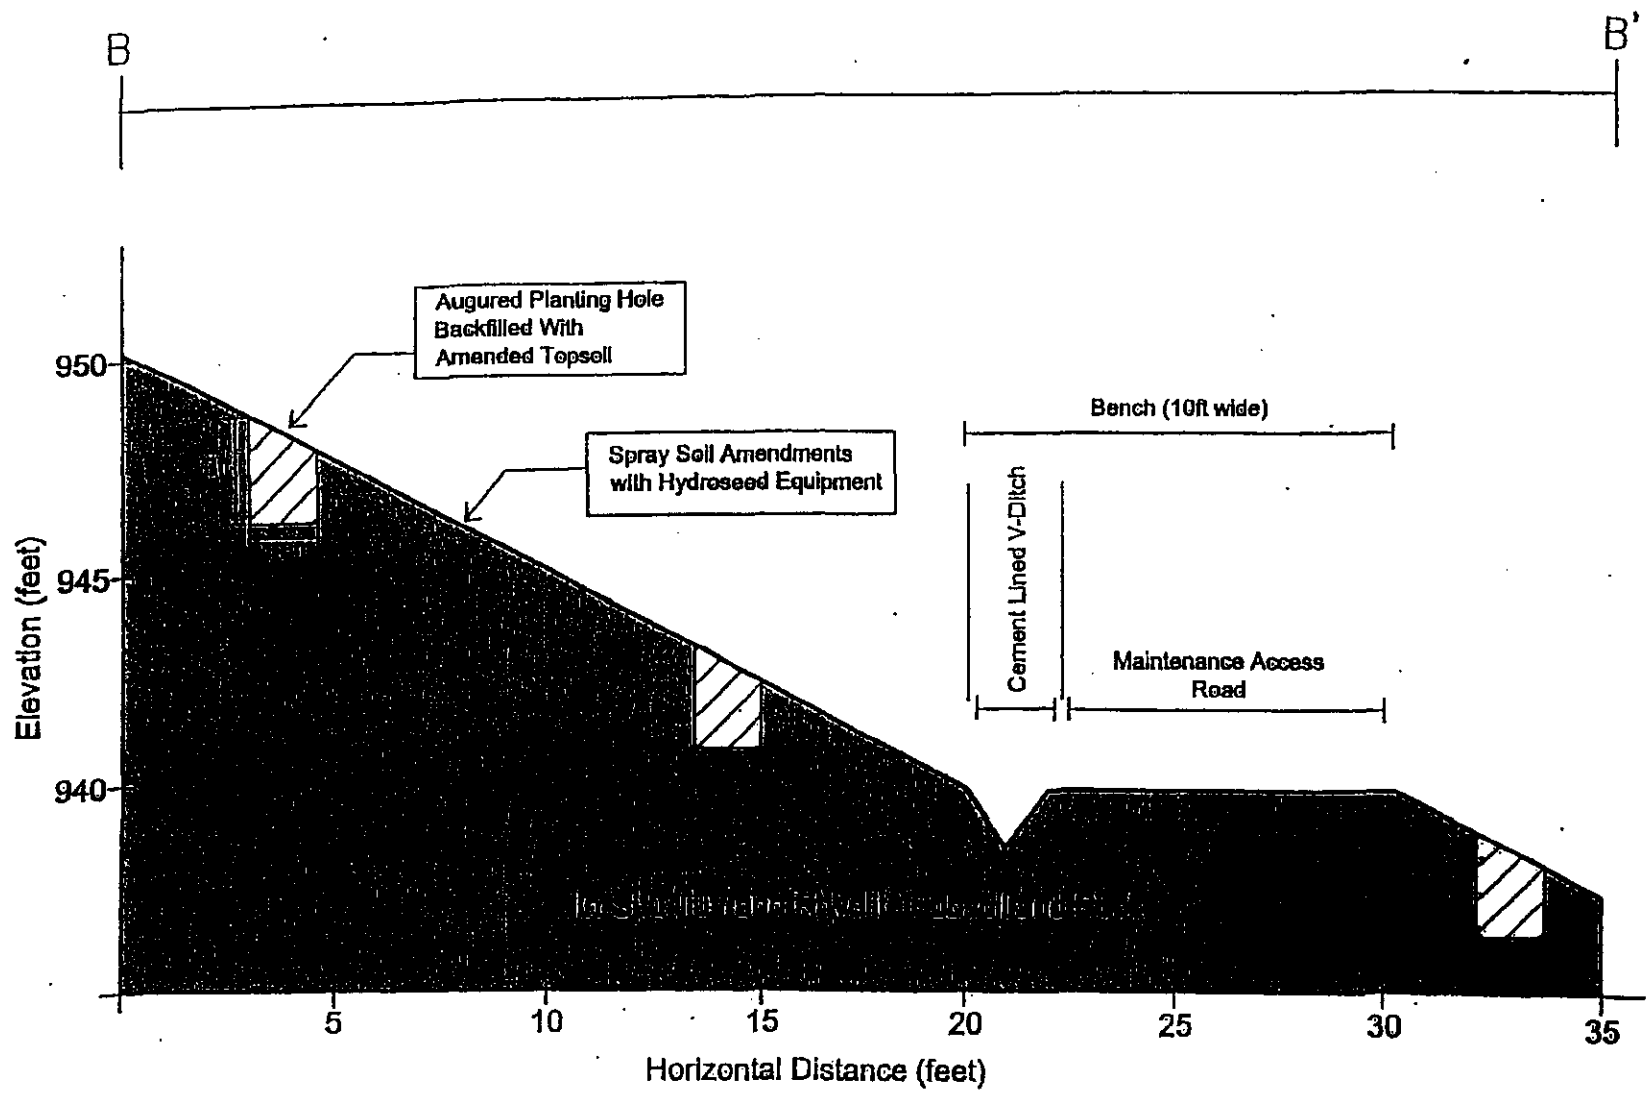
Note: Cross-Section Location Shown on Figure 4

<b>H. T. HARVEY &amp; ASSOCIATES</b> <b>ECOLOGICAL CONSULTANTS</b>		
Cut Slope Soil Preparation and Planting Notes - Typical Section B-B'		
File No. 1950-05	Date 4/16/04	Figure 7

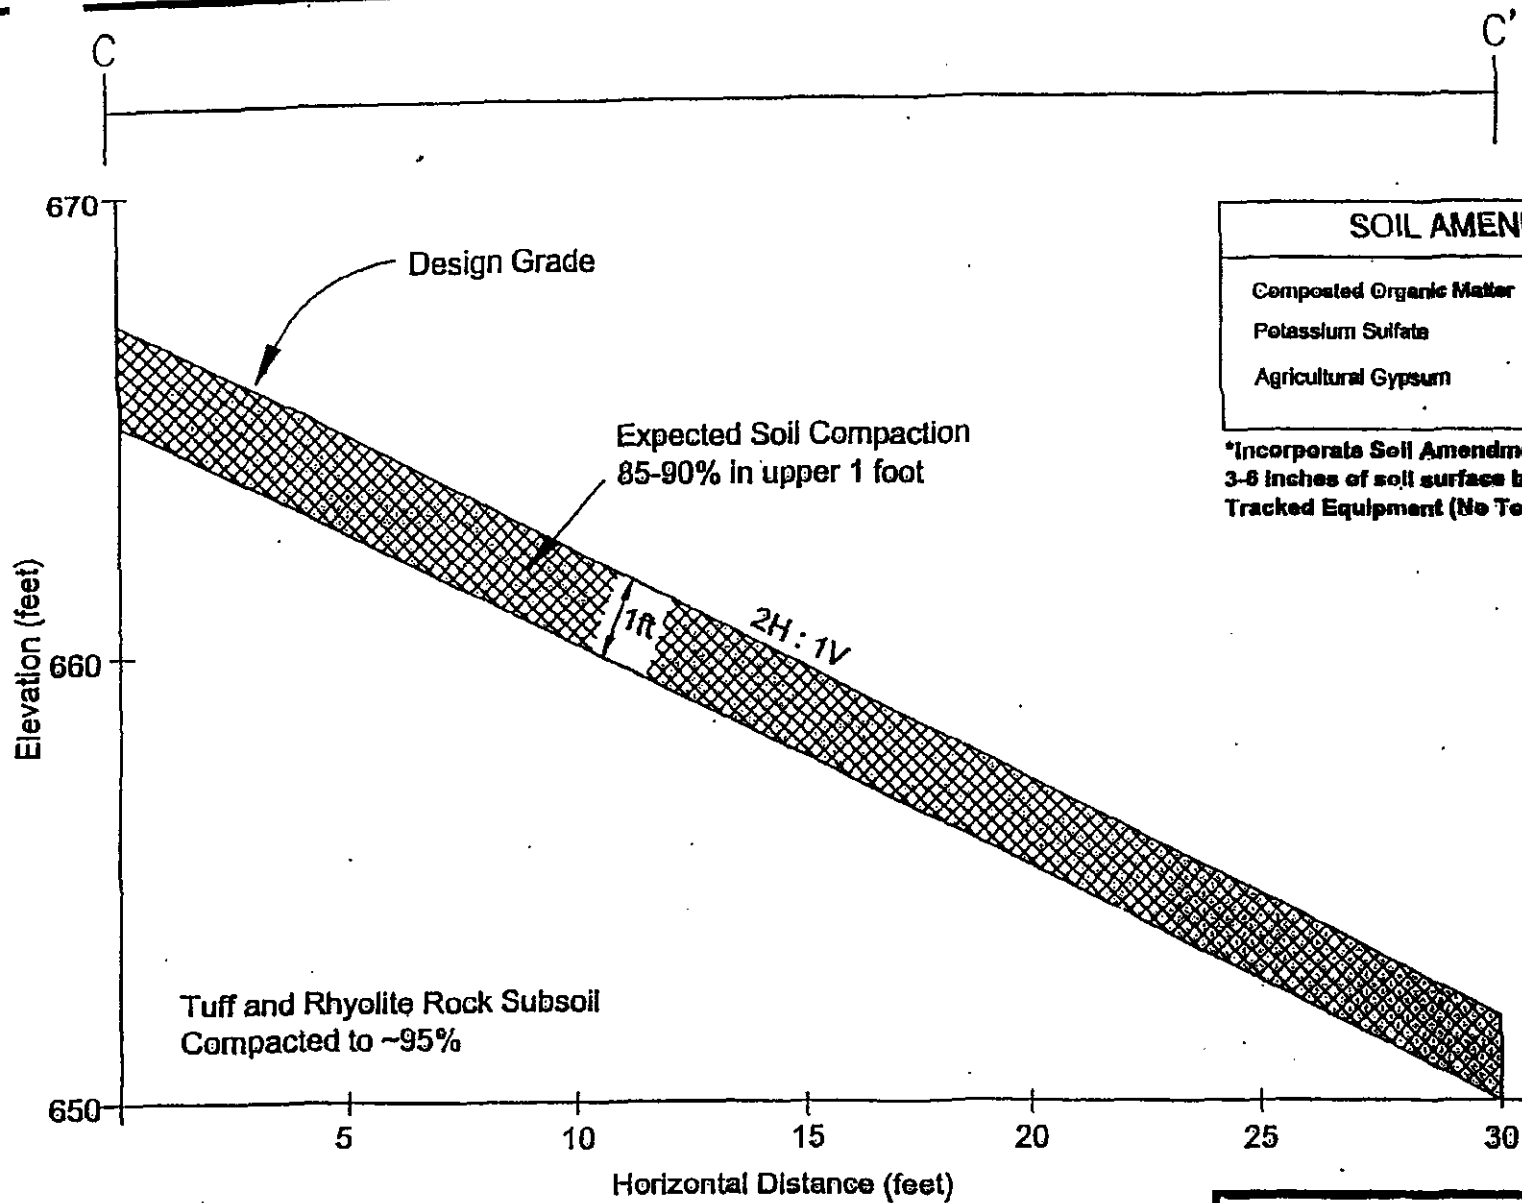
SOIL AMENDMENTS*	
Composted Organic Matter	188 cubic yards/acre
Potassium Sulfate	350 lbs./acre
Agricultural Gypsum	1743 lbs./acre

\*Incorporates Soil Amendments into Upper 3-6 inches of soil surface by using Tracked Equipment (No Topsoil Placement)

Note: Cross-Section Location Shown on Figure 4

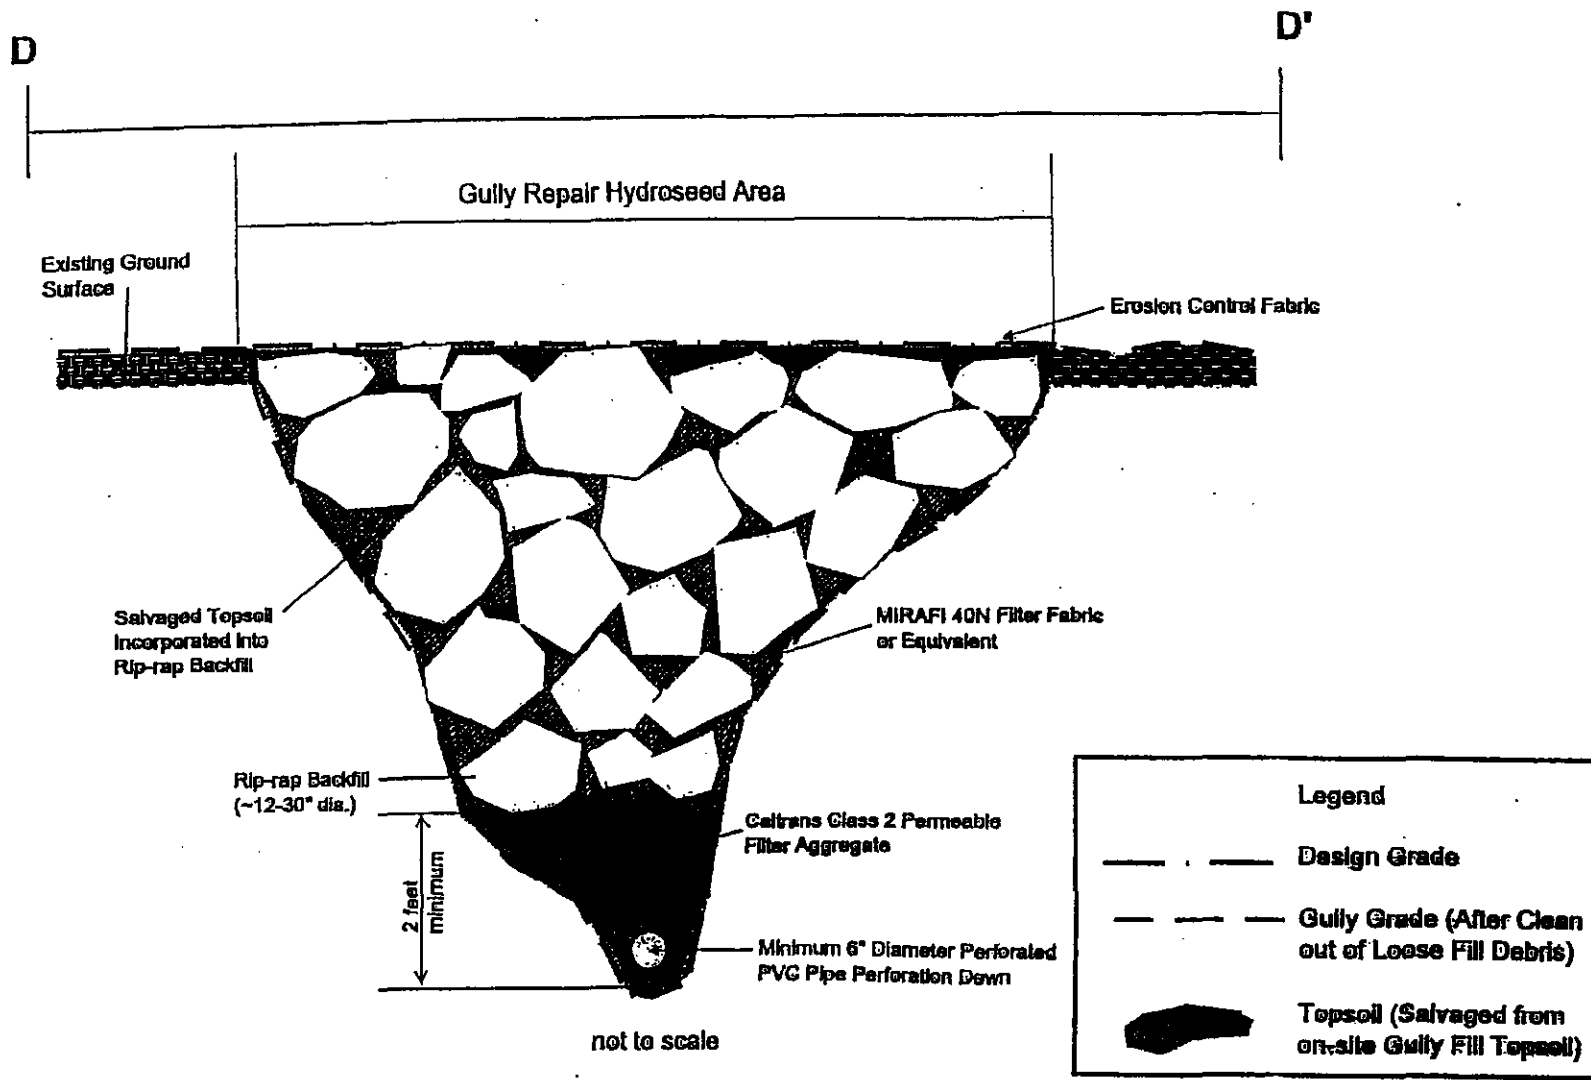
Note: Cross-Section Location Shown on Figure 4

Salvaged soil from the Gully Fill Topsoil will be spread in layers along with the rock riprap within the gully repair sites (Figure 4 and 9). After each layer of rock riprap is set in place, a sufficient quantity of soil will be spread across the rock and allowed to fill-in the voids between the rocks. This will continue until each gully is filled according to the conceptual grading plan. Approximately 670 cubic yards are available for use within the gully repair site, while approximately 350 cubic yards are required (Table 4). The topsoil used for the gully repair sites will not be amended prior to reuse because the site will receive a soil amendment during hydroseed application (see Section 5.3.4).
